The Effects of Nuclear Weapons

Compiled and edited by
Samuel Glasstone *and* Philip J. Dolan

Third Edition

Prepared and published by the
UNITED STATES DEPARTMENT OF DEFENSE
and the
ENERGY RESEARCH AND DEVELOPMENT ADMINISTRATION

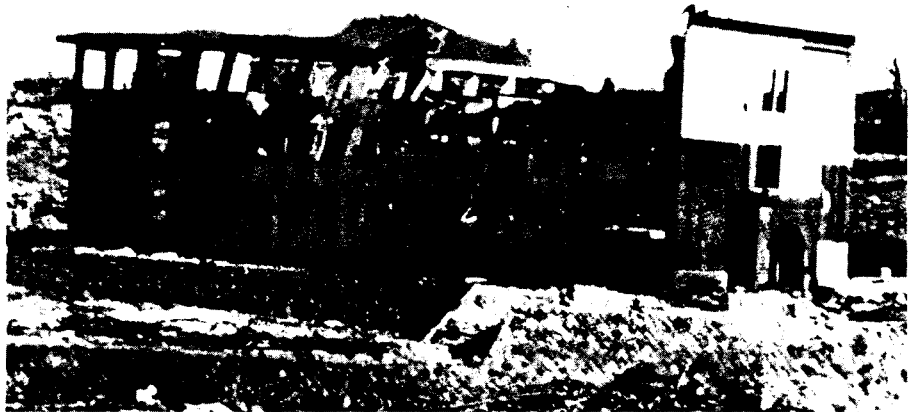
Figure 5.22b. Effects of horizontal loading on wall facing explosion (0.4 mile from ground zero at Nagasaki).

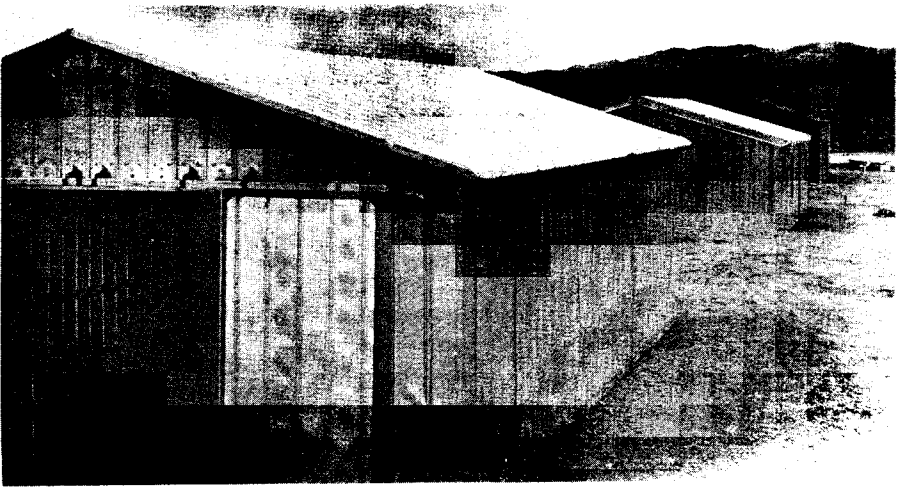
Figure 5.37a. Rigid steel-frame building before a nuclear explosion, Nevada Test Site.

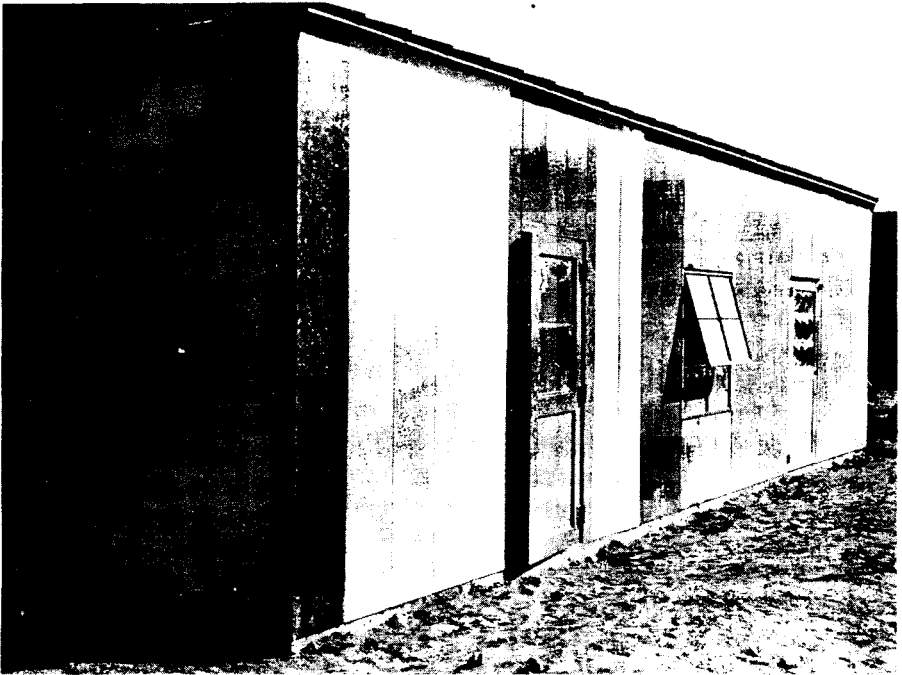
Figure 5.40a. Exterior of self-framing steel panel building before a nuclear explosion, Nevada Test Site.

5.40 A frameless structure with self-supporting walls and roof of light, channel-shaped, interlocking, steel panels (16 inches wide) represented the second standard type of industrial building (Fig. 5.40a). The one subjected to 3.1 pounds per square inch peak overpressure (and a dynamic pressure of

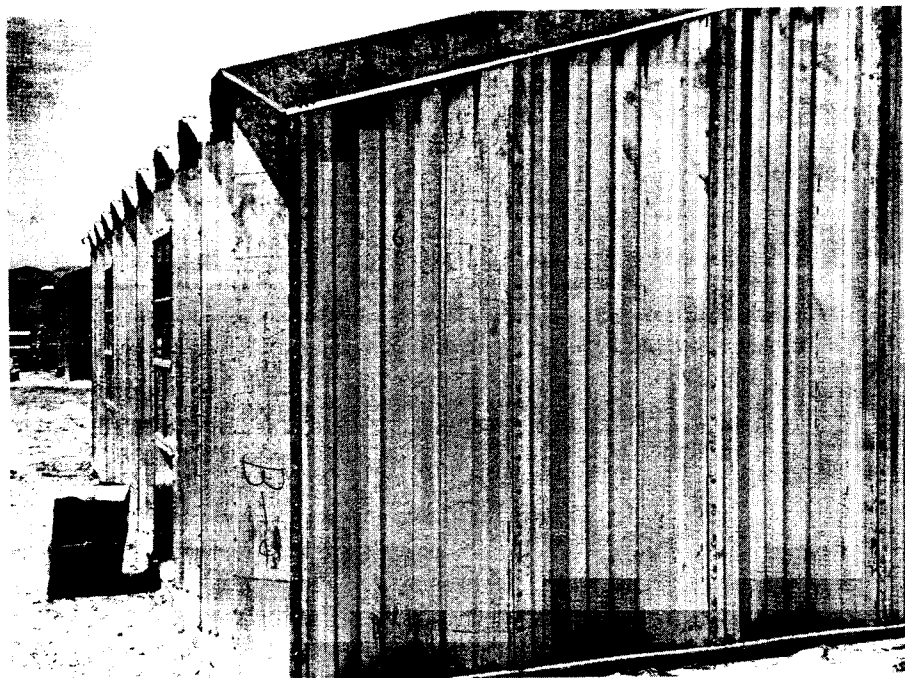
Figure 5.43. Self-framing corrugated steel panel building before a nuclear explosion, Nevada Test Site.

5.43 The third type of industrial building was a completely frameless structure made of strong, deeply-corrugated 43-inch wide panels of 16-gauge steel sheet. The panels were held together with large bolt fasteners at the sides and at the eaves and roof ridge. The wall panels were bolted to the concrete foundation. The entire structure was self-supporting, without frames, girts, or purlins (Fig. 5.43).

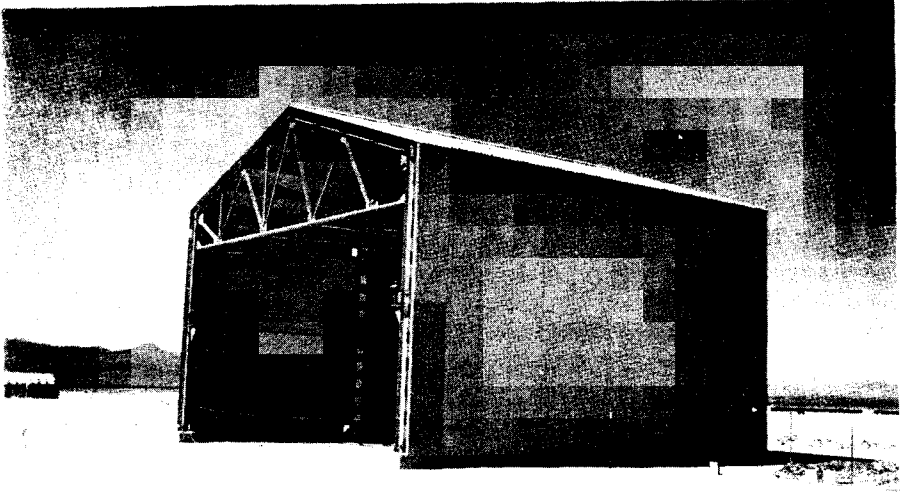
Figure 5.48a. Steel-frame building with siding and roof of frangible material.

tions in the kiloton and megaton ranges. Two representative types of small industrial buildings were chosen for these tests. One had a steel frame covered with siding and roofing of a frangible material and was considered to be a drag-type structure (Fig. 5.48a). The other had the same steel frame and roofing, but it had concrete siding with a window opening of about 30 percent of the wall area; this was regarded as a semidrag structure (Fig. 5.48b).

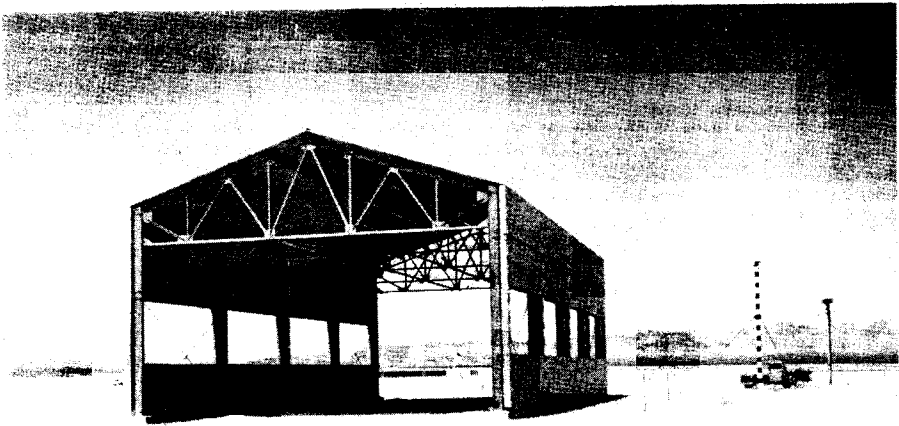
Figure 5.48b. Steel-frame building with concrete siding and window openings of 30 percent of the wall area.

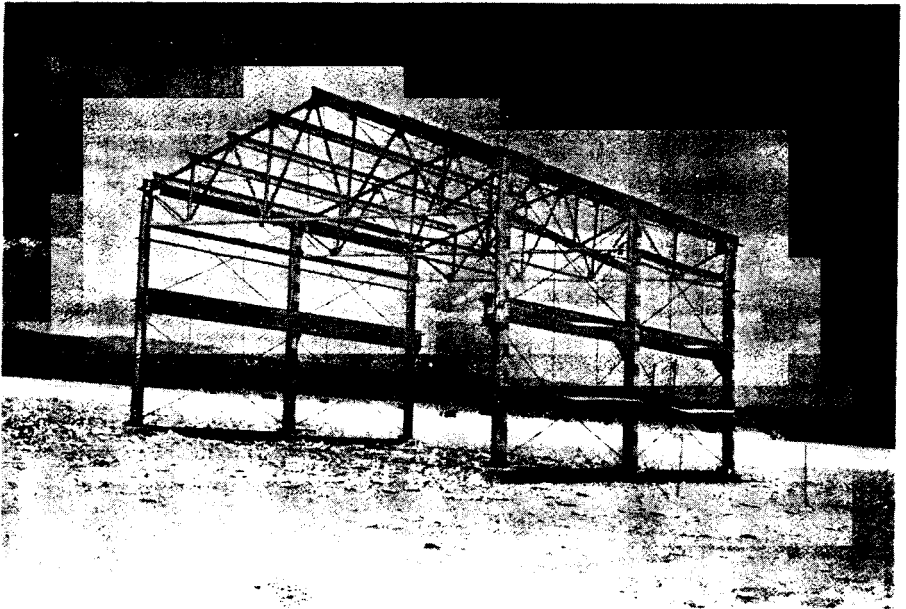
Figure 5.49. Structure in Figure 5.48a after exposure to 6.5 psi peak overpressure and 1.1 psi dynamic pressure; positive phase duration 0.9 second.

bolts failed, and yielding was found between the lower chord (horizontal member of the roof truss) and column connections. The girts on the windward side were severely damaged and all of the siding was completely blown off (Fig. 5.49).

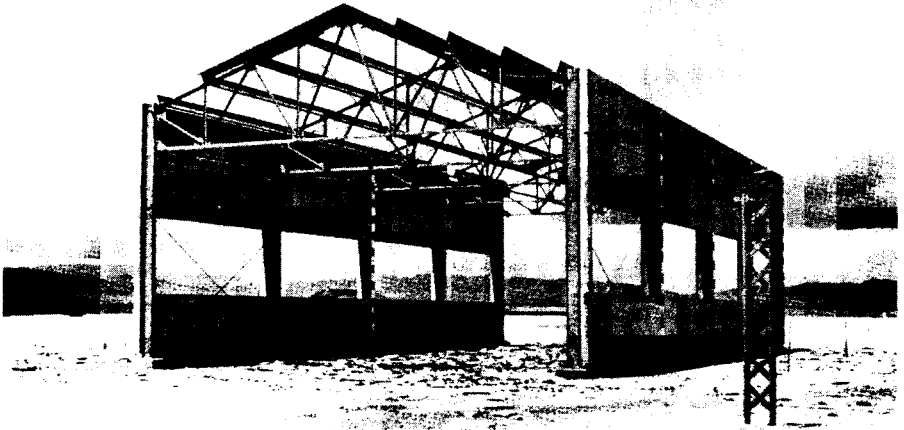
Figure 5.50. Structure in Figure 5.48b after exposure to 3.5 psi peak overpressure and 0.3 psi dynamic pressure; positive phase duration 1 second.

5.50 The second building, with the stronger siding, was exposed in Nevada to a peak overpressure loading of about 3.5 and a dynamic pressure of 0.3 pounds per square inch, with a positive phase duration of 1 second. Damage to this structure was small (Fig. 5.50). Although almost the whole of the frangible roof was blown off, the only other damage observed was a small yielding at some connections and column bases.

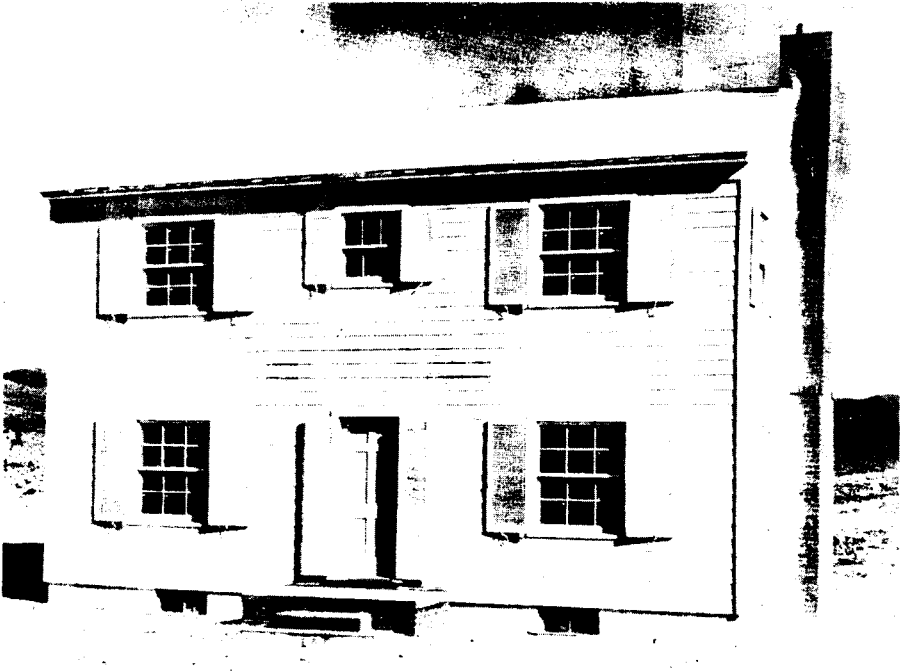
Figure 5.55. Wood-frame house before a nuclear explosion, Nevada Test Site.

different locations. They were of typical wood-frame construction, with two stories, basement, and brick chimney (Fig. 5.55). The interiors were plastered but not painted. Since the tests were intended for studying the effects of blast, precautions were taken to prevent the houses from burning. The exteriors were consequently painted white (except for the shutters), to reflect the thermal radiation. For the same purpose, the windows facing the explosion were equipped with metal venetian blinds having an aluminum finish. In addition, the houses were roofed with light-gray shingles; these were of asbestos cement for the house nearer to the explosion where the chances of fire were greater, whereas asphalt shingles were used for the other house. There were no utilities of any kind.

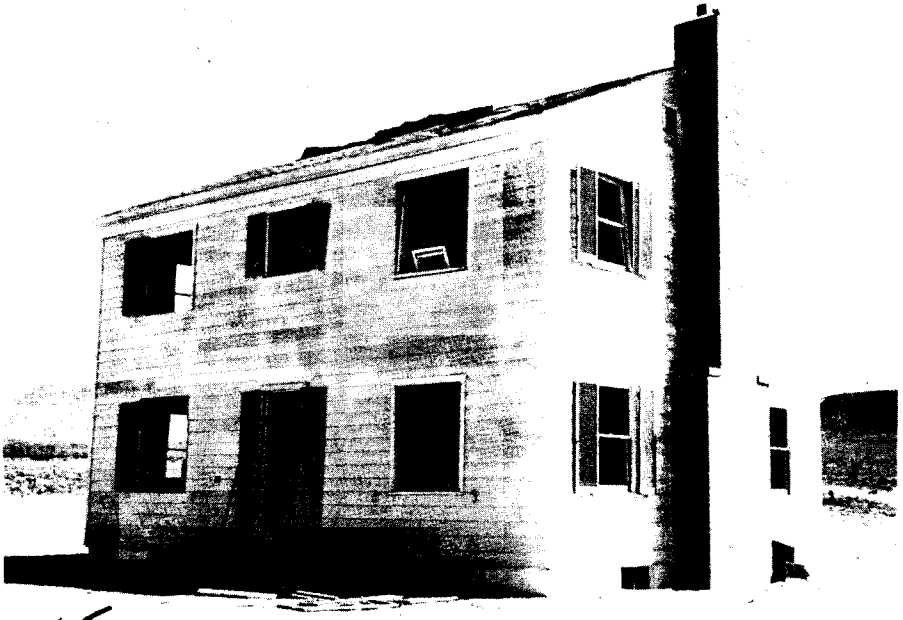
Figure 5.59. Wood-frame house after a nuclear explosion (1.7 psi peak overpressure).

5.59 The second house, exposed to an incident peak overpressure of 1.7 pounds per square inch, was badly damaged both internally and externally, but it remained standing (Fig. 5.59).

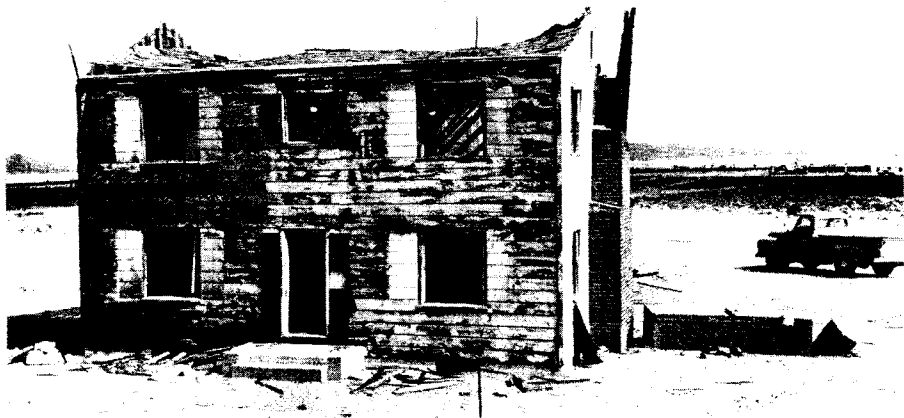
Figure 5.64. Strengthened wood-frame house after a nuclear explosion (4 psi peak overpressure).

5.64 Even with these improvements, it was expected that almost complete destruction would occur at 5 pounds per square inch peak overpressure, and so one of the houses was located where the overpressure at the Mach front would be 4 pounds per square inch. Partly because of the increased strength and partly because of the lower air blast pressure the house did not collapse (Fig. 5.64). But the superstructure was so badly damaged that it could not have been occupied without expensive repair which would not have been economically advisable.

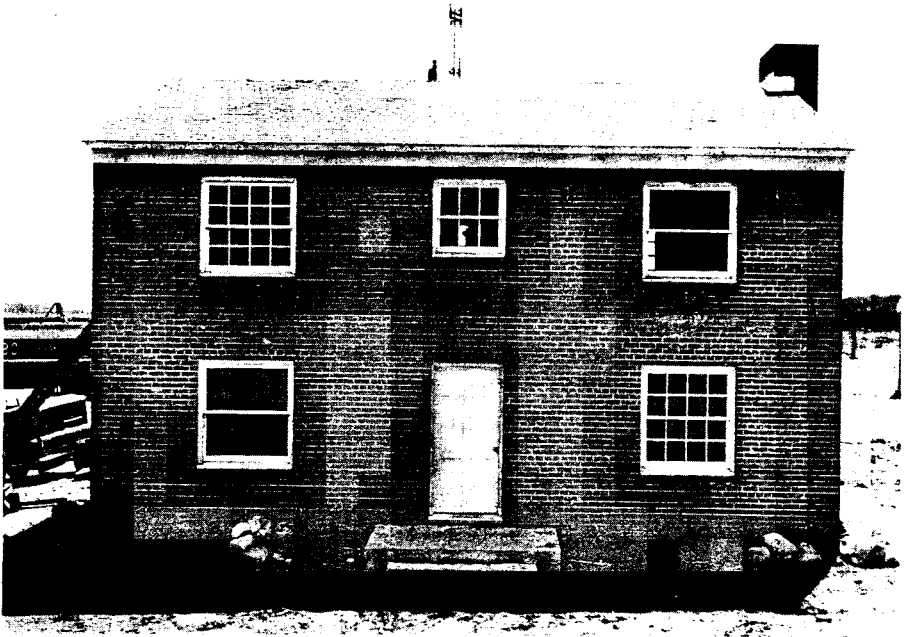
Figure 5.66. Unreinforced brick house before a nuclear explosion, Nevada Test Site.

5.66 For comparison with the tests on the two-story, wood-frame structures made in Nevada in 1953, two brick-wall-bearing houses of conventional construction, similar in size and layout, were exposed to 5 and 1.7 pounds per square inch peak overpressure, respectively, in the 1955 tests (Fig. 5.66). The exterior walls were of brick veneer and cinder block and the foundation walls of cinder block; the floors, partitions, and roof were wood-framed.

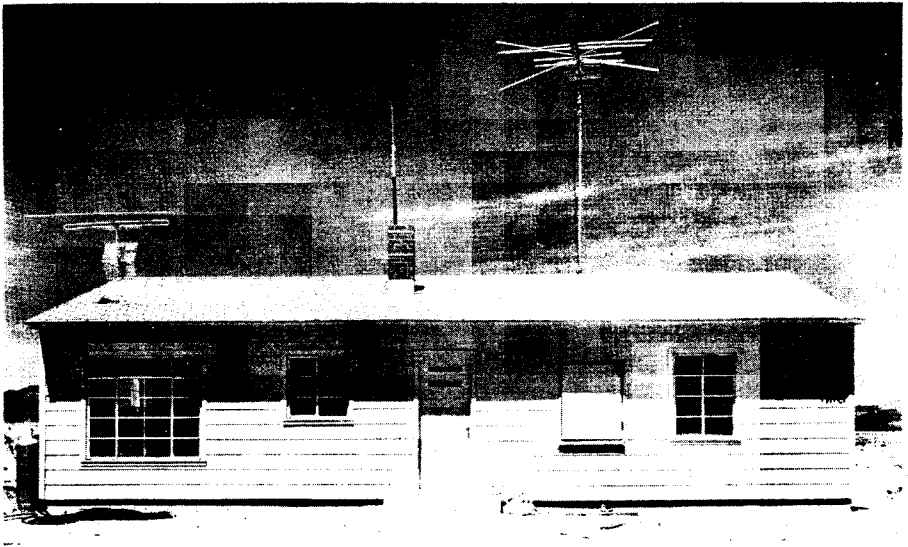
Figure 5.69. Rambler-type house before a nuclear explosion, Nevada Test Site. (Note blast door over bathroom window at right.)

5.69 A pair of the so-called "rambler" type, single-story, wood-frame houses were erected at the Nevada Test Site on concrete slabs poured in place at grade. They were of conventional design except that each contained a shelter, above ground, consisting of the bathroom walls, floor, and ceiling of reinforced concrete with blast door and shutter (Fig. 5.69).

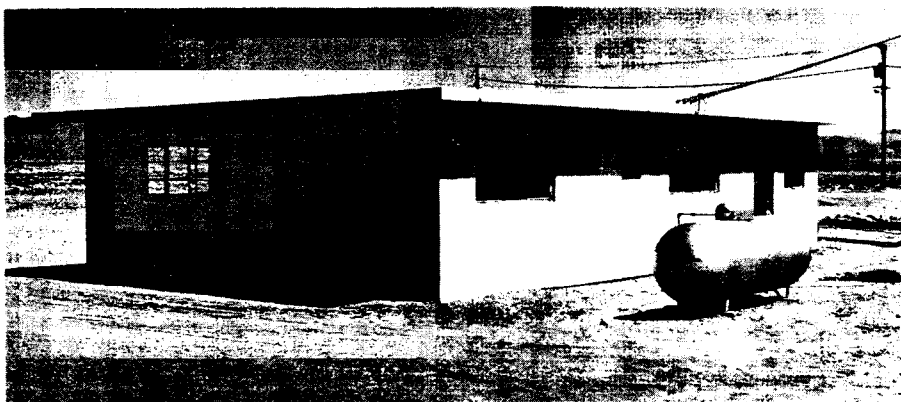
Figure 5.72. Reinforced precast concrete house before a nuclear explosion, Nevada Test Site.

inserts in the wall panels. The overall design was such as to comply with the California code for earthquake-resistant construction (Fig. 5.72).

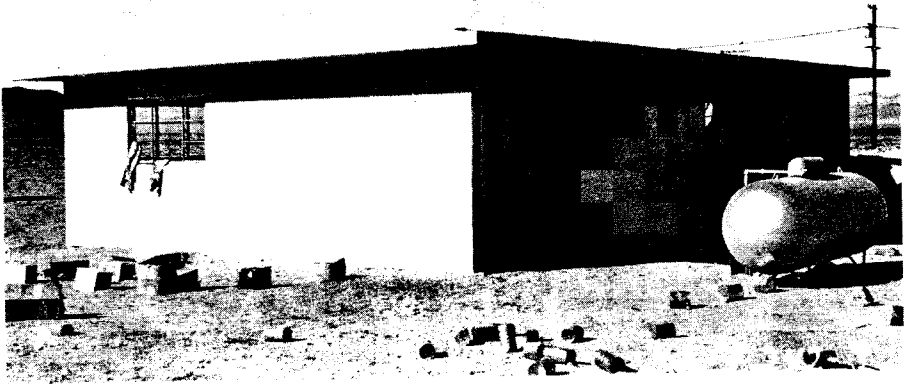
Figure 5.73. Reinforced precast concrete house after a nuclear explosion (5 psi peak overpressure). The LP-gas tank, sheltered by the house, is essentially undamaged.

5.73 This house stood up well, even at a peak overpressure of 5 pounds per square inch. By replacement of demolished or badly damaged doors and windows, it could have been made available for occupancy (Fig. 5.73).

5.74 There was some indication that the roof slabs at the front of the house were lifted slightly from their supports, but this was not sufficient to break any connections. Some of the walls were cracked slightly and others showed indications of minor movement. In certain areas the concrete around the slab connections was spalled, so that the connectors were exposed. The steel

5.119 The 500-gallon bulk gas tanks also proved very durable and experienced little damage. The tank closest to the explosion was bounced end-over-end for a distance of some 700 feet; nevertheless, it suffered only superficially and its strength and serviceability were not impaired. The filler valve was damaged, but the internal check valve prevented escape of the contents. The tank exposed at 10 pounds per square inch peak overpressure was moved about 5 feet, but it sustained little or no damage. All the other tanks, at 5 or 1.7 pounds per square inch, including those at houses piped for service, were unmoved and undamaged (Fig. 5.73).

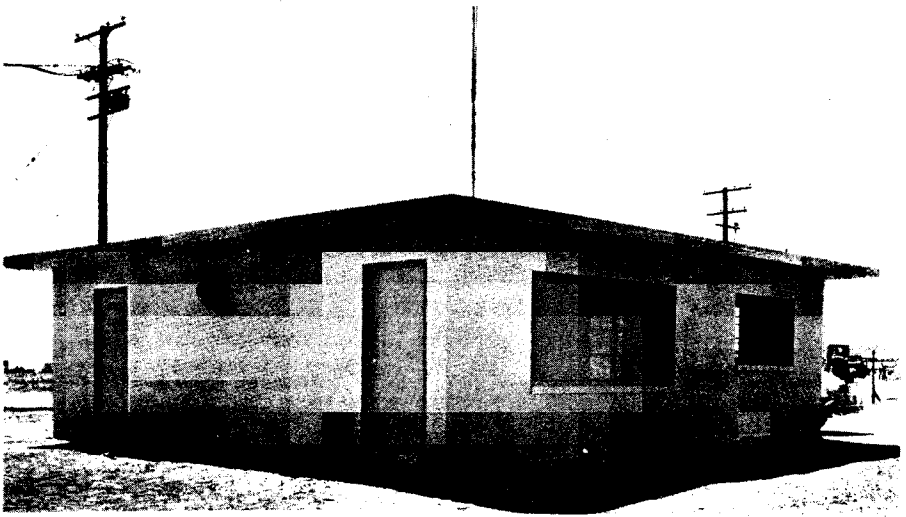
Figure 5.76. Reinforced masonry-block house before a nuclear explosion, Nevada Test Site.

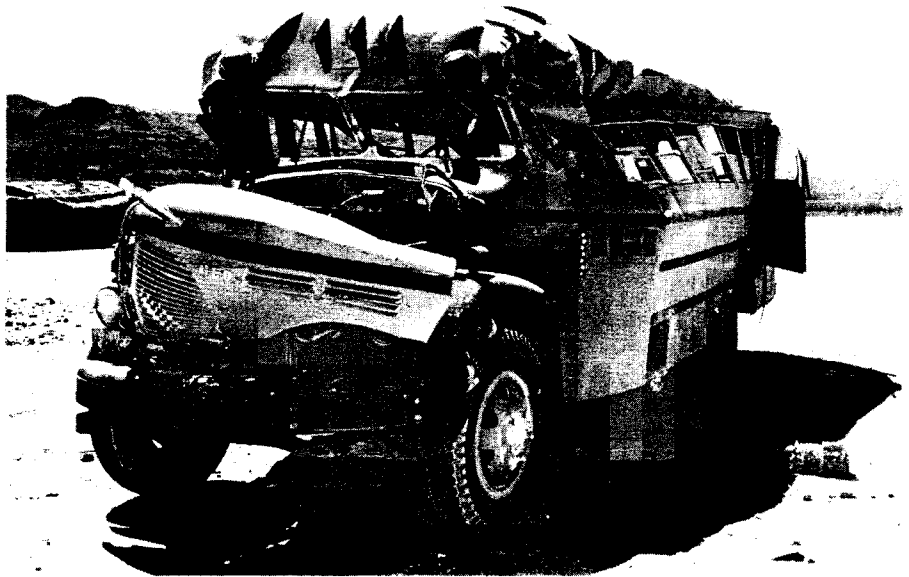
Figure 5.87b. Typical public bus damaged by a nuclear explosion, Nevada Test Site; this bus, like the one in the left background, was overturned, coming to rest as shown after a displacement of 50 feet.

5.87 Some illustrations of the effects of a nuclear explosion on motorized vehicles are shown in Figs. 5.87a and b. At a peak overpressure of 5 pounds per square inch motor vehicles were badly battered, with their tops and sides pushed in, windows broken, and hoods blown open. But the engines were still operable and the vehicles could be driven away after the explosion. Even at higher blast pressures, when the overall damage was greater, the motors appeared to be intact.

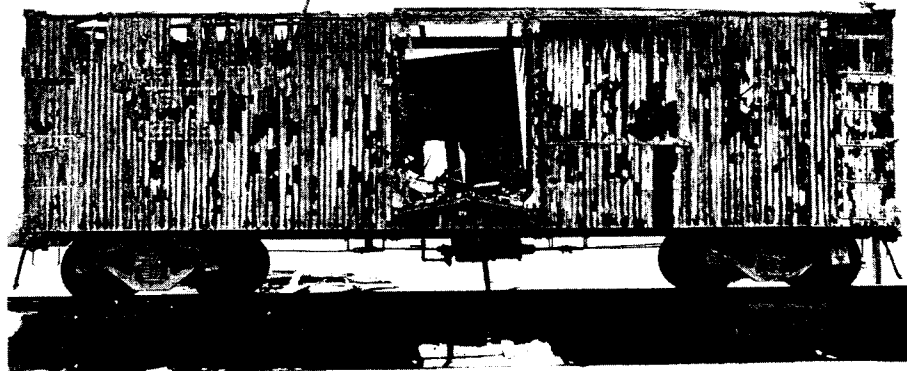
Figure 5.92a. Loaded wooden boxcar after a nuclear explosion (4 psi peak overpressure).

5.92 Railroad equipment suffered blast damage in Japan and also in tests in Nevada. Like motor vehicles, these targets are primarily drag sensitive and damage cannot be directly related to overpressure. At a peak overpressure of 2 pounds per square inch from a kiloton-range weapon, an empty wooden boxcar may be expected to receive relatively minor damage. At 4 pounds per square inch overpressure, the damage to a loaded wooden boxcar would be more severe (Fig. 5.92a). At a peak overpressure of 6 pounds per square inch the

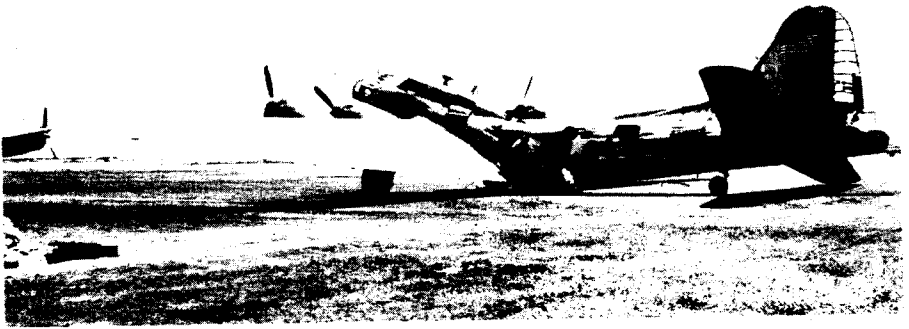
Figure 5.95a. Aircraft after side exposed to a nuclear explosion (3.6 psi peak overpressure).

5.95 Damage to an aircraft exposed with its left side to the blast at a peak overpressure of 3.6 pounds per square inch is shown in Fig. 5.95a. The fuselage of this aircraft failed completely just aft of the wing. The skin of the fuselage, stabilizers, and engine cowling was severely buckled. Figure 5.95b shows damage to an aircraft oriented with its tail toward the burst and exposed to 2.4 pounds per square inch peak overpressure. Skin was dished in on the vertical stabilizer, horizontal stabilizers, wing surface above the flaps, and outboard wing sections. Vertical stabilizer bulkheads and the fuselage frame near the cockpit were buckled.

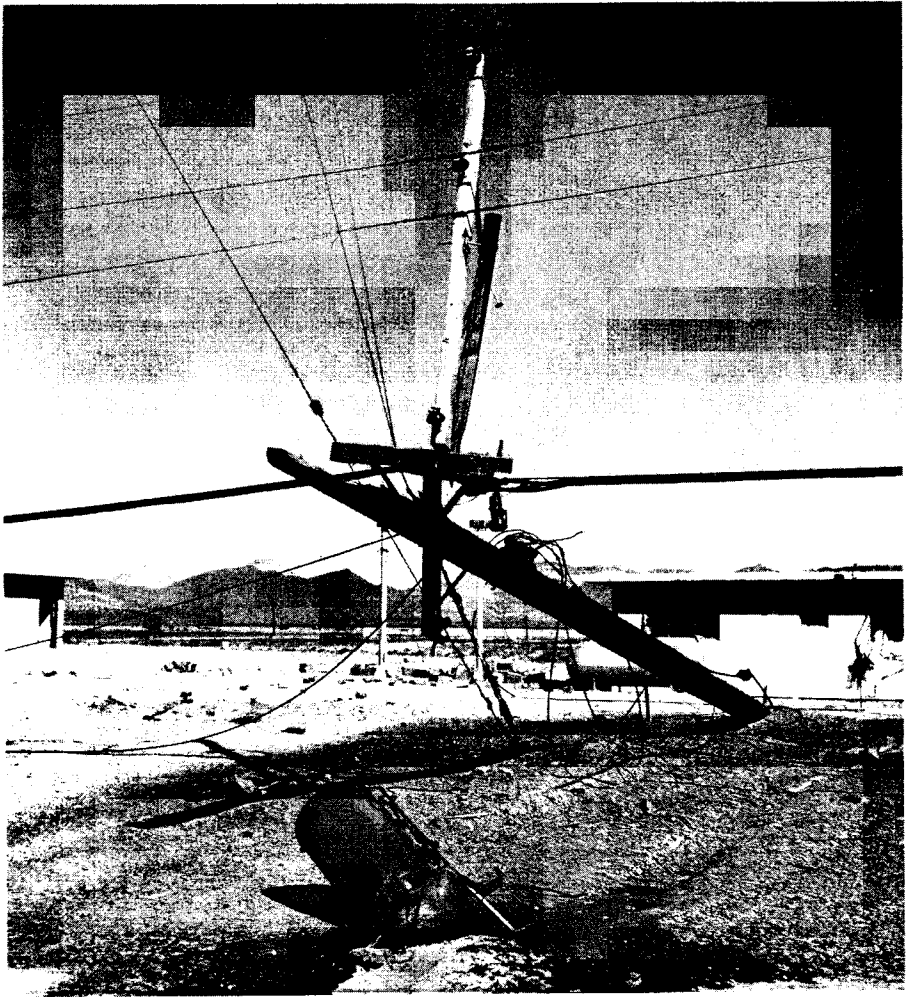
Figure 5.105. Transformer fallen from collapsed utility pole (5 psi peak overpressure), Nevada Test Site.

secondary wires and service drops were down (Fig. 5.105). Nevertheless the transformers, pot heads, arresters, cut-outs, primary conductors of both aluminum and copper, and the aerial cables

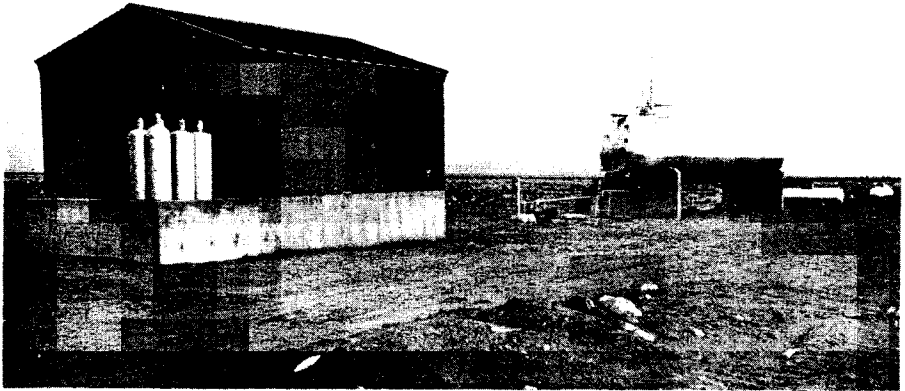
Figure 5.120. Upper photo: LP-gas bulk storage and filling plant before a nuclear explosion. Lower photo: The plant after the explosion (5 psi peak overpressure).

18,000-gallon bulk storage and filling plant received only superficial damage from the blast at 5 pounds per square inch peak overpressure. The cylinder-filling building was completely demolished; the scale used for weighing the cylinders was wrecked, and a filling line was broken at the point where it entered the building (Fig. 5.120). The major operating services of the plant would, however, not be affected because the transfer facilities were outside and undamaged. All valves and nearly all piping in the plant were intact and there

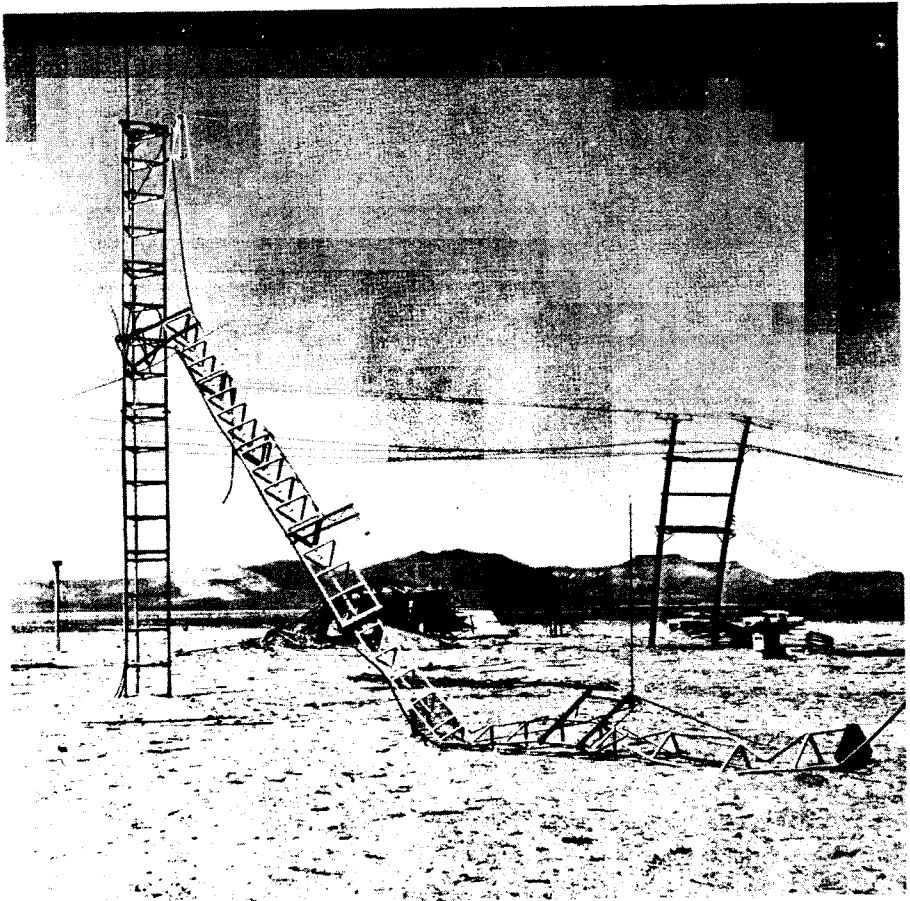
Figure 5.124. Unguyed lightweight 120-foot antenna tower (5 psi peak overpressure, 0.6 psi dynamic pressure from 30-kiloton explosion), Nevada Test Site.

5.125 The base station antennas, which were on the towers, appeared to withstand blast reasonably well, although those attached to the unguyed tower, referred to above, suffered when the tower collapsed. As would have been expected from their lighter construction, television antennas for home receivers were more easily damaged. Several were bent both by the blast and the collapse of the houses upon which they were mounted. Since the houses were generally damaged beyond repair at a peak overpressure of 5 pounds per square inch, the failure of the television antennas is not of great significance.

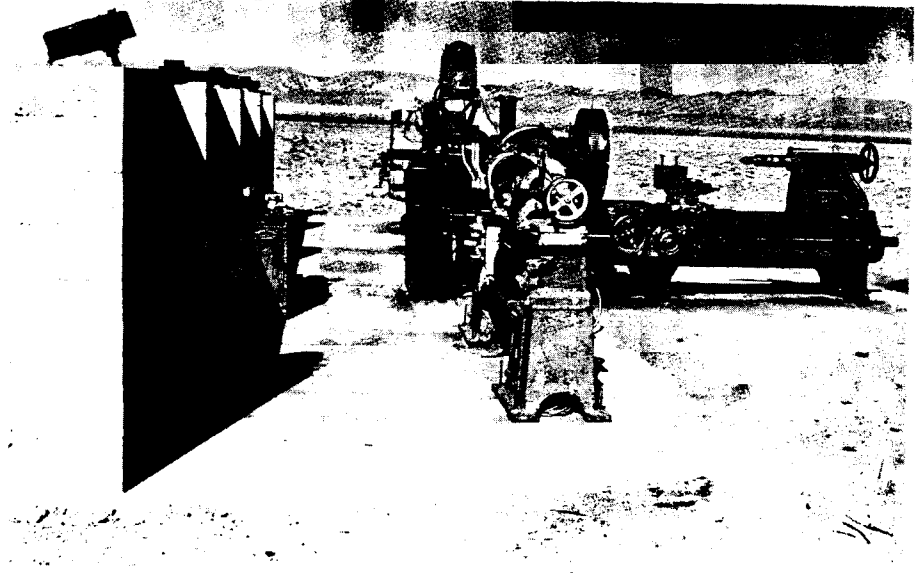
Figure 5.128. Machine tools behind masonry wall before a nuclear explosion, Nevada Test Site.

concrete slab in such a manner as to duplicate good industrial practice. Two engine lathes (weighing approximately 7,000 and 12,000 pounds, respectively), and two horizontal milling machines (7,000 and 10,000 pounds, respectively) were exposed to a peak overpressure of 10 pounds per square inch. A concrete-block wall, 8 inches thick and 64 inches high, was constructed immediately in front of the machines, i.e., between the machines and ground zero (Fig. 5.128). The purpose of this wall was to simulate the exterior wall of the average industrial plant and to provide debris and missiles.

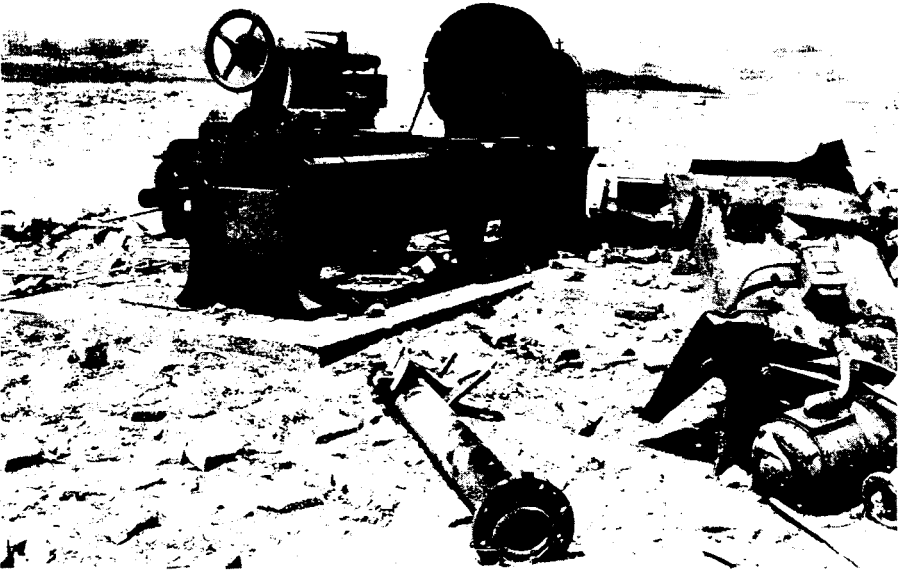
Figure 5.129b. Heavy-duty lathe after a nuclear explosion (10 psi peak overpressure).

5.129 Of the four machines, the three lighter ones were moved from their foundations and damaged quite badly (Fig. 5.129a). The fourth, weighing 12,000 pounds, which was considered as the only one to be actually of the heavy-duty type, survived (Fig. 5.129b). From the observations it was concluded that a properly anchored machine tool of the true heavy-duty type would be able to withstand peak overpressures of 10 pounds per square inch or more without substantial damage.

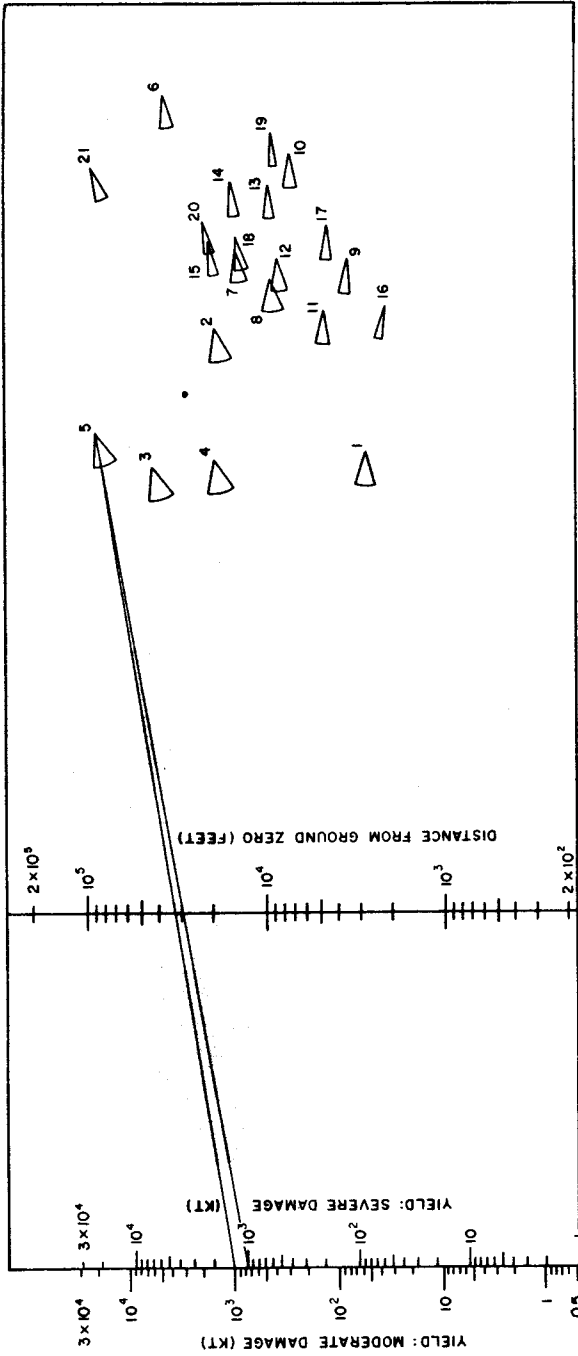
The various above-ground structures in Fig. 5.140 are identified (Items 1 through 21) and the different types of damage are described in Tables 5.139a and b. The "fan" from each point indicates the range of yields for which the diagram may be used. For a surface burst multiply the damage distances obtained from the diagram by three-fourths. The results are estimated to be accurate within ± 20 percent for the average target conditions specified in § 5.141.

Figure 5.140. Damage-distance relationships for above ground structures.

5.136 For a number of types of targets, the distances out to which different degrees of damage may be expected from nuclear explosions of various yields have been represented by diagrams, such as Figs. 5.140 and 5.146. These are based on observations made in Japan and at various nuclear tests, on experiments conducted in shock tubes in laboratories and with high-explosives in field tests, and on theoretical analyses of the loading and response of structures (see Chapter IV). As a result of these studies, it is possible to make reasonably accurate predictions of the response of interior as well as exterior wall panels and complete structures to the air-blast wave. These predictions, however, must take into account constructional details of each individual structure. Moreover, observations made during laboratory tests have indicated a large scatter in failure loadings as a result of statistical variations among wall and material properties. The data in Figs. 5.140 and 5.146 are intended, however,

5.140 The ranges for severe and moderate damage to the structures in Tables 5.139a and b are presented in Fig. 5.140, based on actual observations and theoretical analysis. The numbers (1 to 21) in the figure identify the target types as given in the first column of the tables. The data refer to air bursts with the height of burst chosen so as to maximize the radius of damage for the particular target being considered and is not necessarily the same for different targets. For a surface burst, the respective ranges are to be multiplied by three-fourths. An example illustrating the use of the diagram is given.

5.141 The data in Fig. 5.140 are for certain average target conditions. These are that (1) the target is at sea level (no correction is necessary if the target altitude is less than 5,000 feet); (2) the terrain is fairly flat (rugged terrain would provide some local shielding and protection in certain areas and local enhancement of damage in others); and (3) the structures have average characteristics (that is, they are of average size and strength and that orientation of the target with respect to the burst is no problem, i.e., that the ratio of loading to resistance is relatively the same in all directions from the target).

5.143 Figure 5.140 gives the distances from ground zero for severe and moderate damage. Light damage to all targets except blast-resistant structures and bridges can be expected at the range at which the overpressure is 1 pound per square inch. For the blast-resistant structure (Type 1) described in Table 5.139a, a peak overpressure of 10 pounds per square inch should be used to estimate the distance for light damage. Light damage to bridges can be expected at the range at which 0.6

5.144 The foregoing results do not take into consideration the possibility of fire. Generally speaking, the direct effects of thermal radiation on the structures and other targets under consideration are inconsequential. However, thermal radiation may initiate fires, and in structures with severe or moderate damage fires may start because of disrupted gas and electric utilities. In some cases, as in Hiroshima (§ 7.71), the individual fires may develop into a mass fire which may exist throughout a city, even beyond the range of significant blast damage. The spread of such a fire depends to a great extent on local weather and other conditions and is therefore difficult to predict. This limitation must be kept in mind when Fig. 5.140 is used to estimate the damage to a particular city or target area.

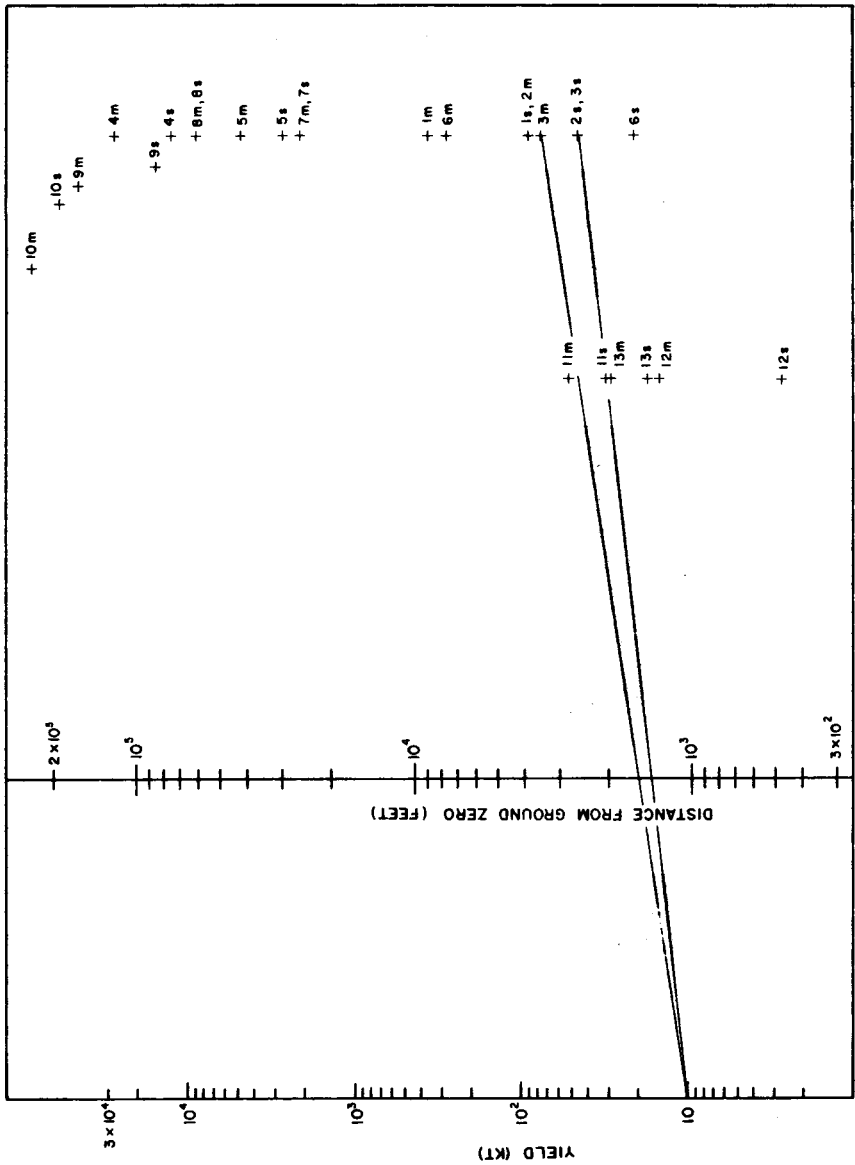
Figure 5.146. Damage-distance relationships for drag-sensitive targets.

5.146 A diagram of damage-distance relationships for various targets which are largely affected by drag forces is given in Fig. 5.146. The conditions under which it is applicable and the

limits of accuracy are similar to those in § 5.141 and § 5.142, respectively; the possibility of fire mentioned in § 5.144 must also be kept in mind. The targets (Items 1 to 13) in the figure are enumerated on the page facing Fig. 5.146 and the different types of damage are described in the following paragraphs.

The drag-sensitive targets in Fig. 5.146 are identified as follows:

5.150 The damage-distance results derived from Fig. 5.146 apply in particular to unimproved coniferous forests which have developed under unfavorable growing conditions and to most deciduous forests in the temperate zone when foliation is present. Improved coniferous forests, with trees of uniform height and a smaller average tree density per acre, are more resistant to blast than are unimproved forests which have grown under unfavorable conditions. A forest of defoliated deciduous trees is also somewhat more blast resistant than is implied by the data in Fig. 5.146.

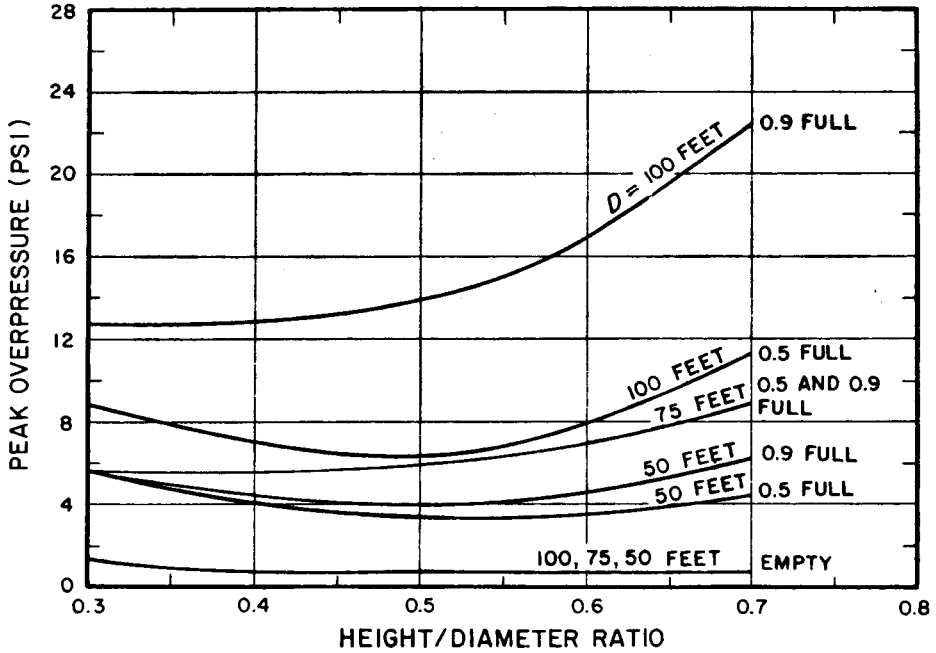
Figure 5.155a. Peak overpressures for severe blast damage to floating- or conical-roof tanks of diameter D for explosions from 1 to 500 kilotons.

from the tank as a consequence of sloshing. There is apparently no clear-cut overall structural collapse which initially limits the usefulness of the tank. Peak overpressures required for severe damage to POL tanks of diameter D may be obtained from Figs. 5.155a and b. Figure 5.155a is applicable to nuclear explosions with energy yields from 1 to 500 kilotons and Fig. 5.155b to yields over 500 kilotons. For yields less than 1 kiloton, the peak overpressure for severe damage may be taken to be 1 pound per square inch.

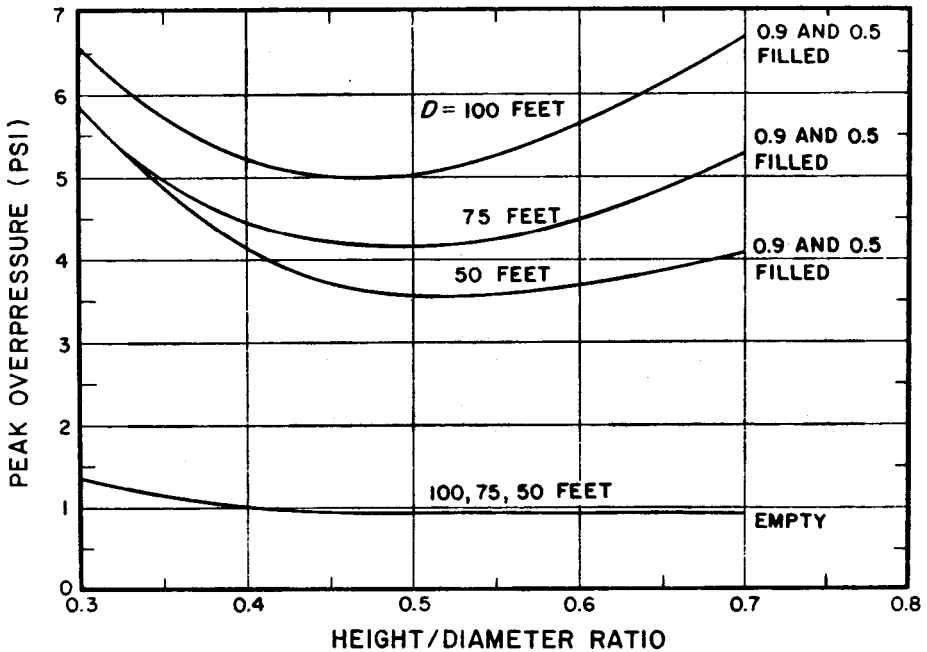
Figure 5.155b. Peak overpressures for severe blast damage to floating- or conical-roof tanks of diameter D from explosions of 500 kilotons or more.
